**AIR ACCIDENT
INVESTIGATION UNIT**

REVIEW
OF IRISH & UK FILES
ON THE LOSS OF THE AER LINGUS VISCOUNT
ST. PHELIM
REGISTRATION EI-AOM
ON 24 MARCH 1968

Report of the review of EI-712, St. Phelim,

Tuskar Rock, 24 March 1968

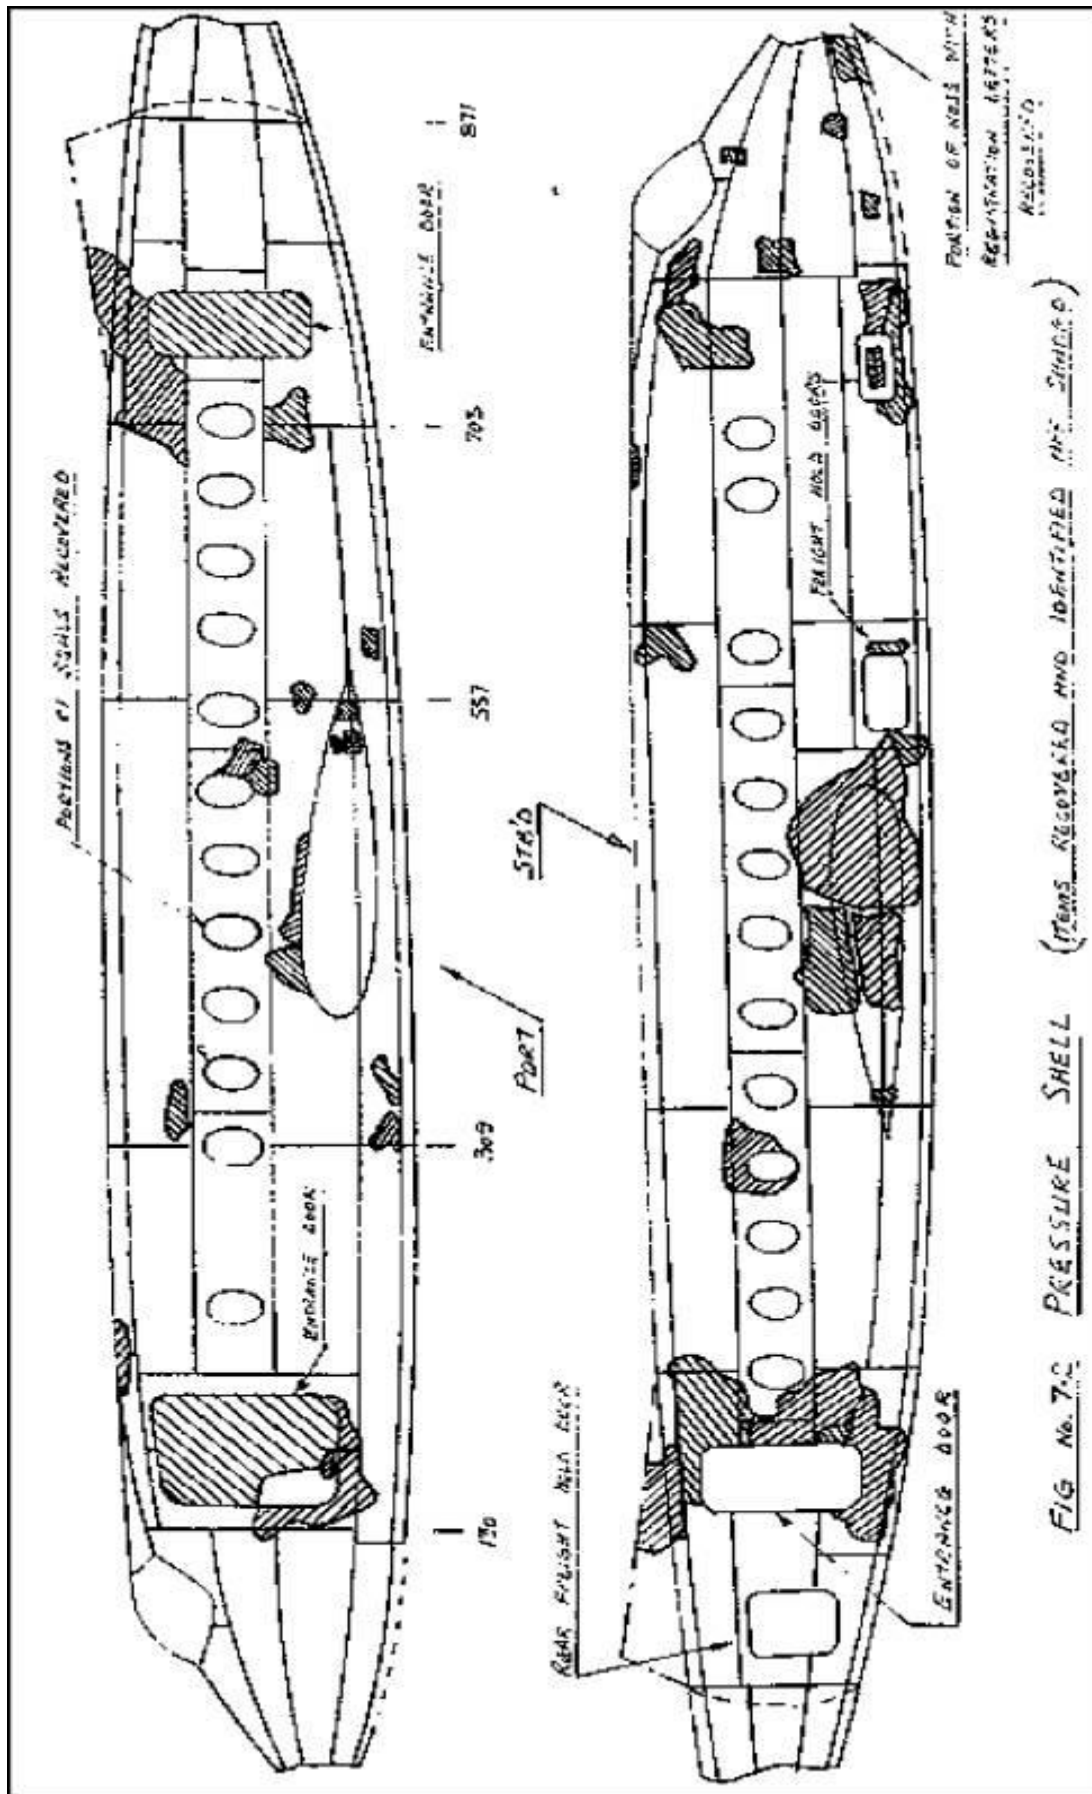
The following diagram is taken from Appendix 4(a) Airframe and Equipment. As stated the shaded areas are the items recovered.
